# ENGINEERING CONDITION SURVEY AND STRUCTURAL INVESTIGATION OF MONTGOMERY LOCKS AND DAM OHIO RIVER

March 1977

Final Report

Prepared for U. S. Army Engineer District, Pittsburgh  
Pittsburgh, Pa. 15222

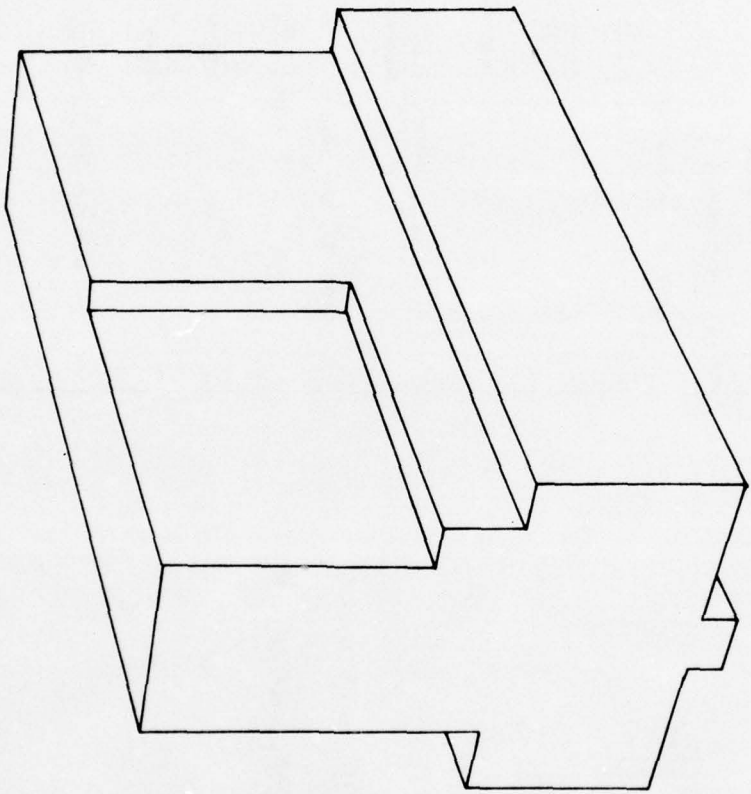
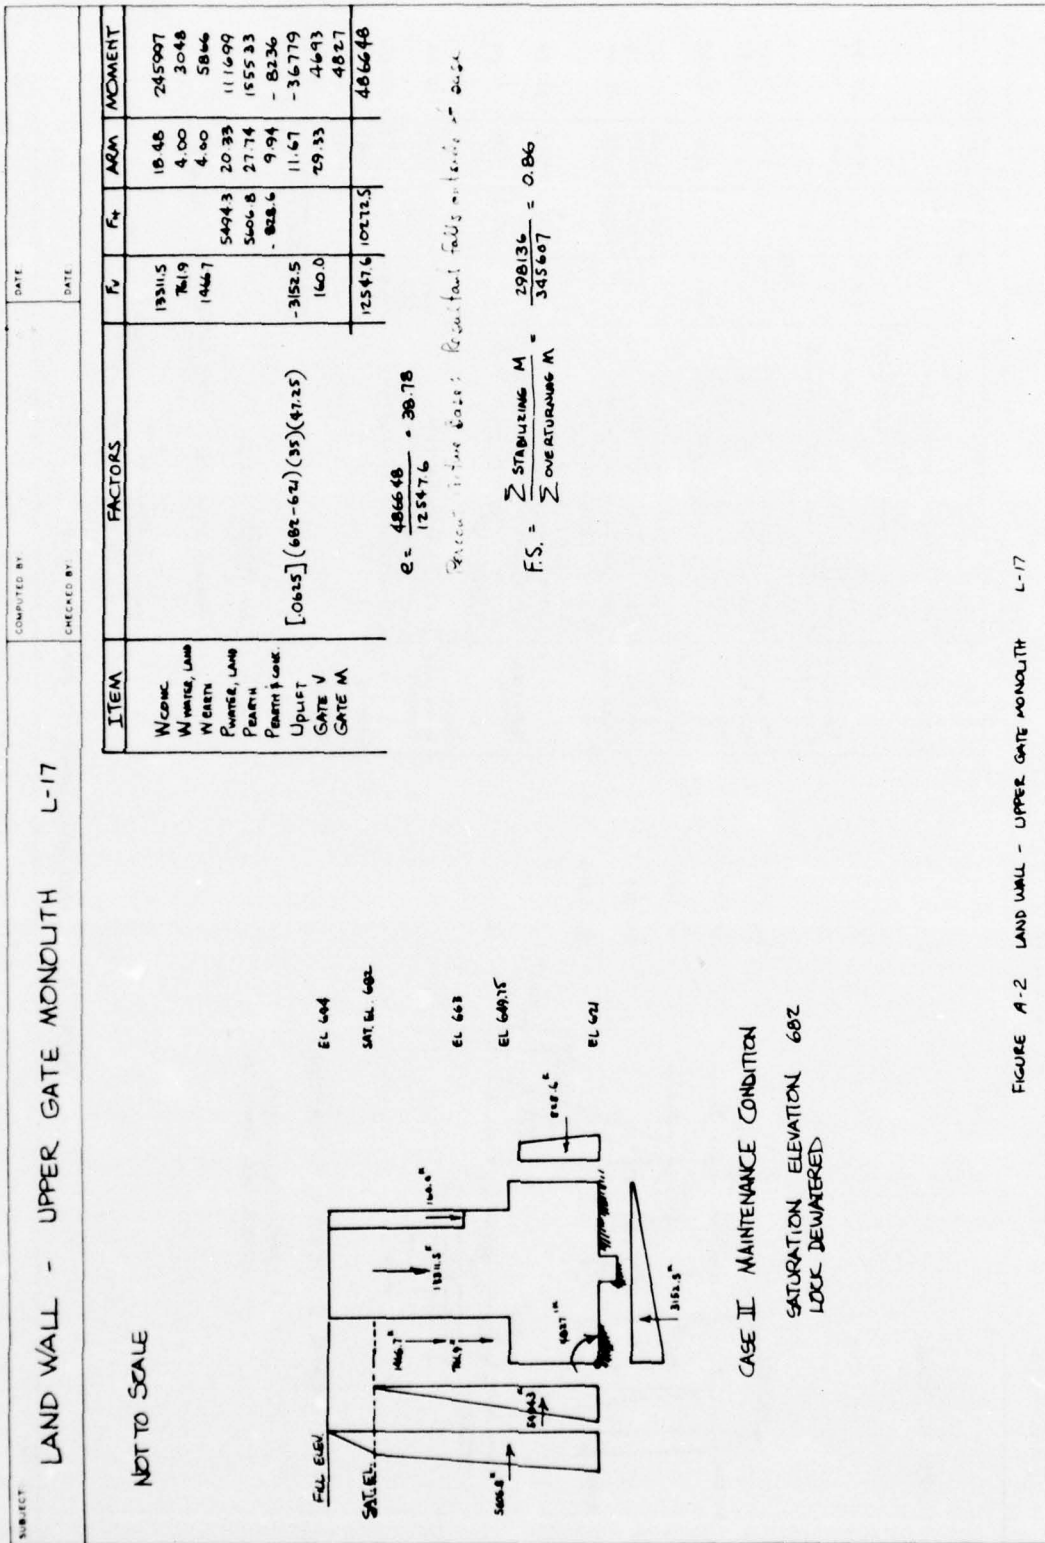
FIGURE A-2 LAND WALL - UPPER GATE MONOLITH L-17

$$FS = \frac{\sum \text{STABILIZING } M}{\sum \text{OVERTURNING } M} = \frac{390017}{376321} = 1.04$$

SUBJECT:	LAND WALL - UPPER GATE MONOLITH L-17		COMPUTED BY:	DATE:
			CHECKED BY:	DATE:
SLIDING	<p>CASE I NORMAL OPERATIONS</p> $R = \sum F_i \tan \phi + \text{key Resistance}$ $= (10804.6)(5658) + (8)(47.25)(44)(.075)$ $= 6113.2 + 4082.4$ $= 10195.6$ $SSF = 10195.6 / 6192.7$ $= 1.65$	<p>BASE PRESSURE</p> <p>CASE I NORMAL OPERATIONS</p> $f = \left(\frac{2}{3}\right) \left(\frac{L^2}{6}\right) / L$ $= \frac{(2)(10804.6)}{(3)(35-38.75)} / 47.25$ $= 120.0 \text{ KSF}$	<p>CASE II MAINTENANCE CONDITION</p> <p>Base Pressures are Very large</p>	
	<p>CASE II MAINTENANCE CONDITION</p> $R = (12547.6)(5658) + 4082.4$ $= 7099.4 + 4082.4$ $= 11181.8$ $SSF = 11181.8 / 10272.5$ $= 1.09$

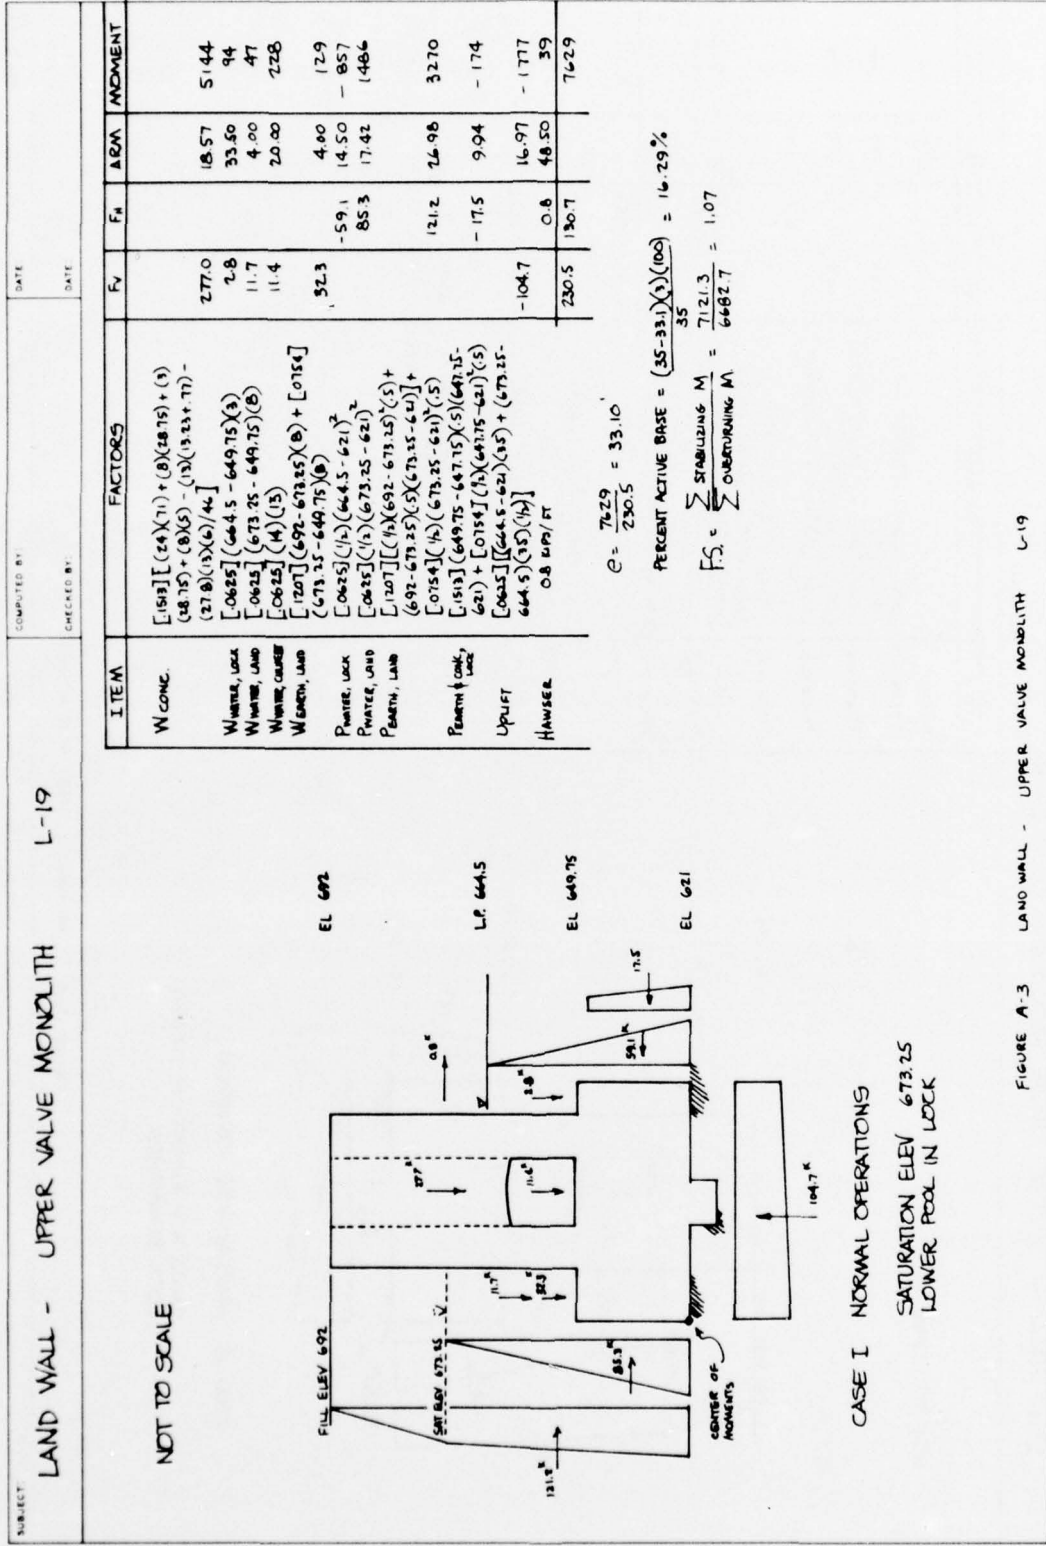
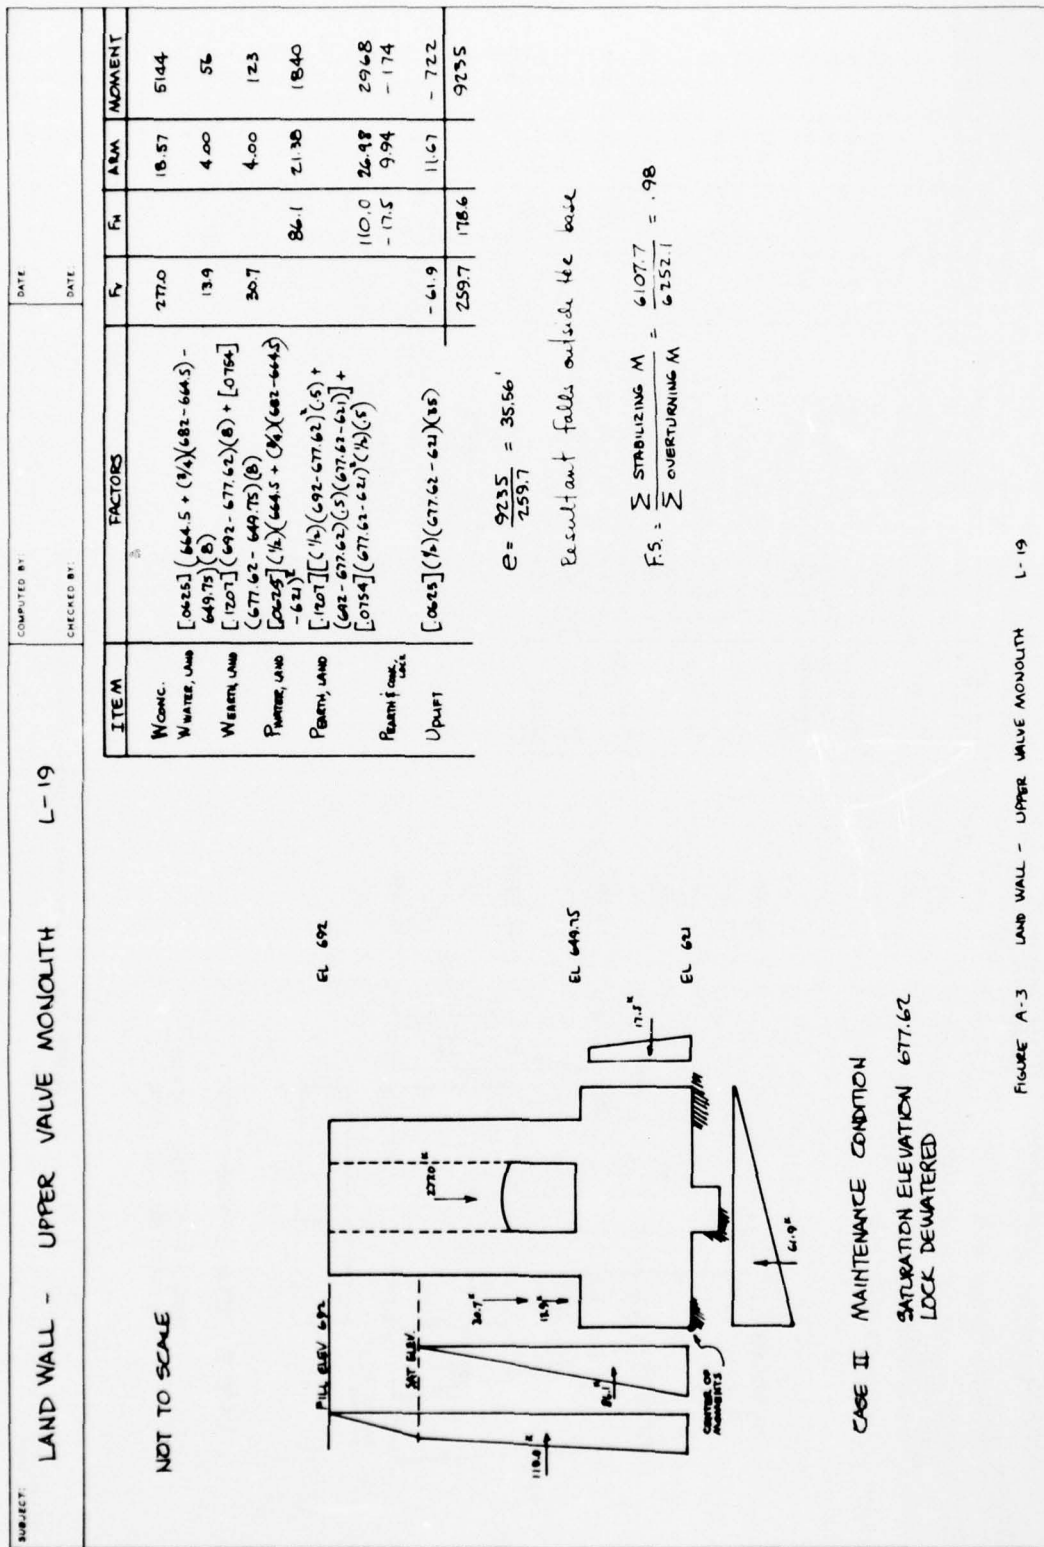
FIGURE A-3 LAND WALL - UPPER VALVE MONOLITH L-19

SUBJECT:	LAND WALL - UPPER VALVE MONOLITH L-19	COMPUTED BY:	DATE:
		CHECKED BY:	DATE:
SLIDING	<p>CASE I NORMAL OPERATIONS</p> $R = \sum F_v \tan \phi + \text{KEY RESISTANCE}$ $= (230.5)(.5658) + (8)(.1)(.075)(144)$ $= 130.4 + 86.4$ $= 216.8$ $SSF = 216.8 / 130.7$ $= 1.66$	BASE PRESSURE	<p>CASE I NORMAL OPERATIONS</p> $f = \frac{2}{3} p$ $= \frac{(2)(230.5)}{(3)(35-33.1)}$ $= 80.9 \text{ KSF}$
CASE II MAINTENANCE CONDITION	<p>CASE II MAINTENANCE CONDITION</p> $R = (259.7)(.5658) + 86.4$ $= 233.3$ $SSF = 233.3 / 178.6$ $= 1.31$	CASE II MAINTENANCE CONDITION	<p>Base Resistances are very large</p>

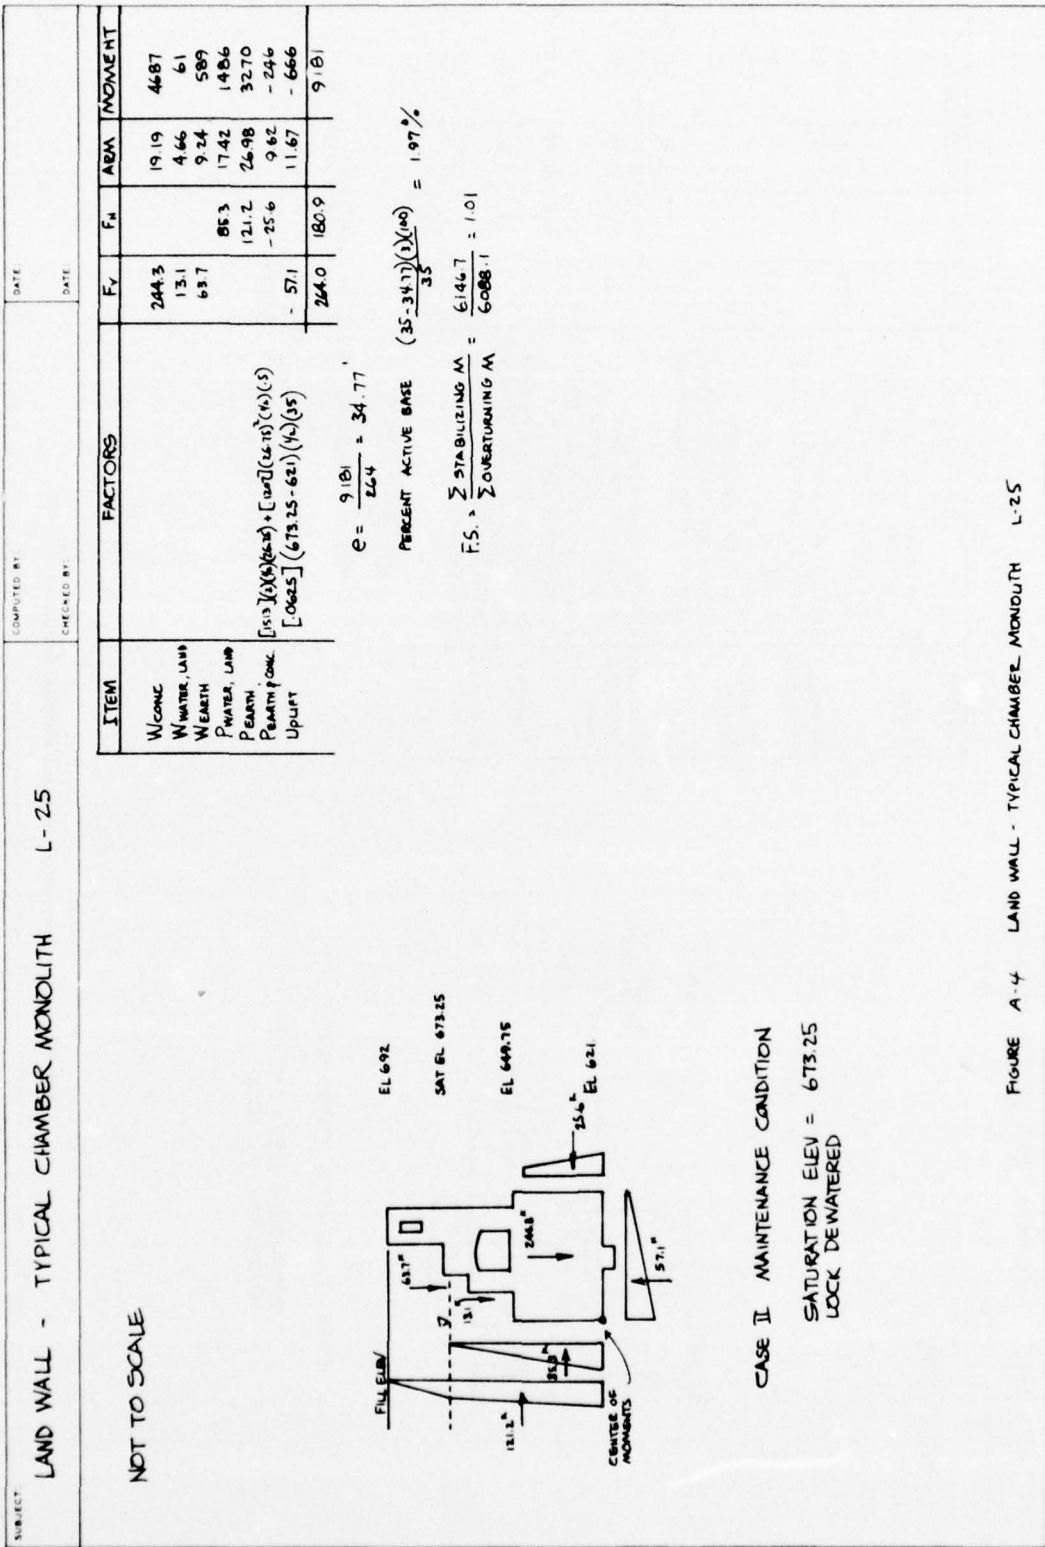
FIGURE A-4 LAND WALL - TYPICAL CHAMBER MONOLITH L-25

SUBJECT	LAND WALL TYPICAL CHAMBER MONOLITH L-25	COMPUTED BY: CHECKED BY:	DATE	DATE
<p>SLIDING</p> <p>CASE I NORMAL OPERATIONS</p> $R = ZF_u \tan \phi + \text{Key Resistance}$ $= (228.8)(56.8) + (8)(0.15)(144)$ $= 129.5 + 86.4$ $= 215.9$ $SSF = 215.9 / 127.9$ $= 1.66$	<p>BASE PRESSURE</p> <p>CASE I NORMAL OPERATIONS</p> $f = \frac{2}{3} \frac{P}{q}$ $= \frac{(2)(228.8)}{(3)(55-33.09)}$ $= 79.8 \text{ KSF}$			
<p>CASE II MAINTENANCE CONDITION</p> $R = (264)(56.8) + 86.4$ $= 149.4 + 86.4$ $= 235.8$ $SSF = 235.8 / 120.9$ $= 1.90$	<p>CASE II MAINTENANCE CONDITION</p> $f = \frac{2}{3} \frac{P}{q}$ $= \frac{(2)(264)}{(3)(55-33.77)}$ $= 765.2 \text{ KSF}$

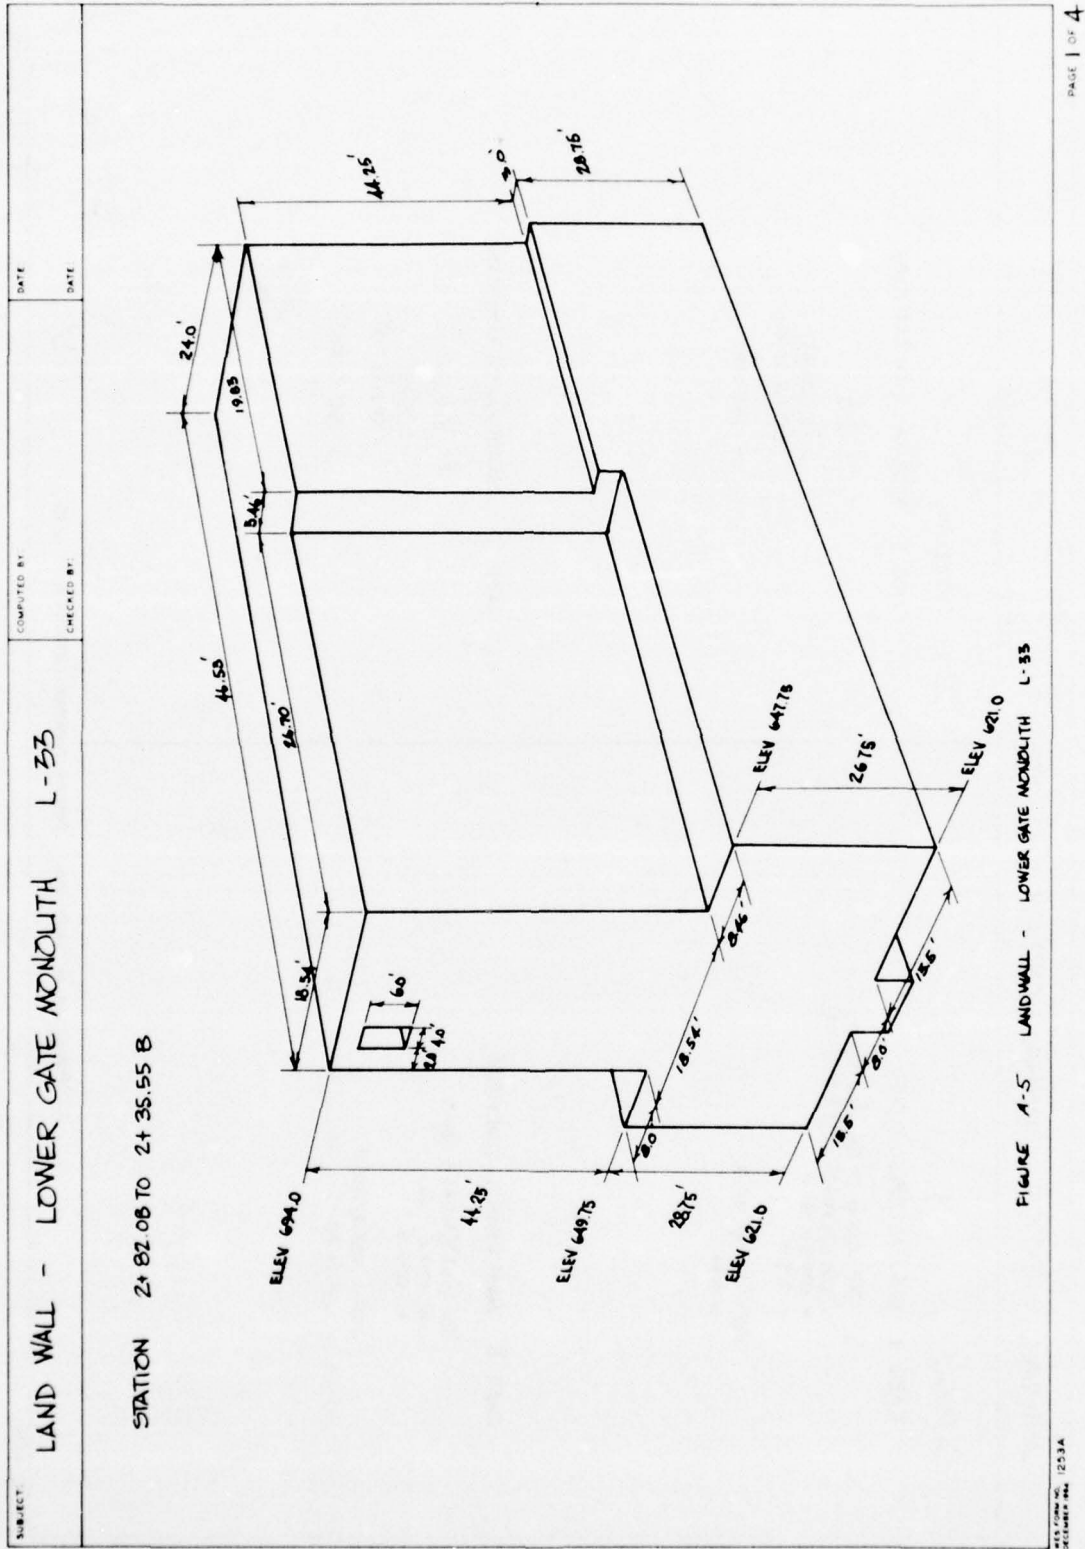
FIGURE A-5 LANDWALL - LOWER GATE MONOLITH L-33

SUBJECT: LAND WALL - LOWER GATE MONOLITH L-33		COMPUTED BY: _____ DATE: _____	CHECKED BY: _____ DATE: _____
<p><b>SLIDING</b></p> <p><b>CASE I NORMAL OPERATIONS</b></p> $R = \sum F_v \tan \phi + \text{Key Resistance}$ $= (10680.3)(.5658) + (8)(46.53)(144)(.075)$ $= 6042.9 + 4020.2$ $= 10063.1$ $FSF = 10063.1 / 6853.5 =$ $= 1.47$		<p><b>BASE PRESSURE</b></p> <p><b>CASE I NORMAL OPERATIONS</b></p> <p>Base Pressures Very Large</p>	
<p><b>CASE II MAINTENANCE CONDITION</b></p> $R = (11855.3)(.5658) + 4020.2$ $= 6707.7 + 4020.2$ $= 10727.9$ $FSF = 10727.9 / 10046.5$ $= 1.07$		<p><b>CASE II MAINTENANCE CONDITION</b></p> <p>Base Pressure Very Large</p>

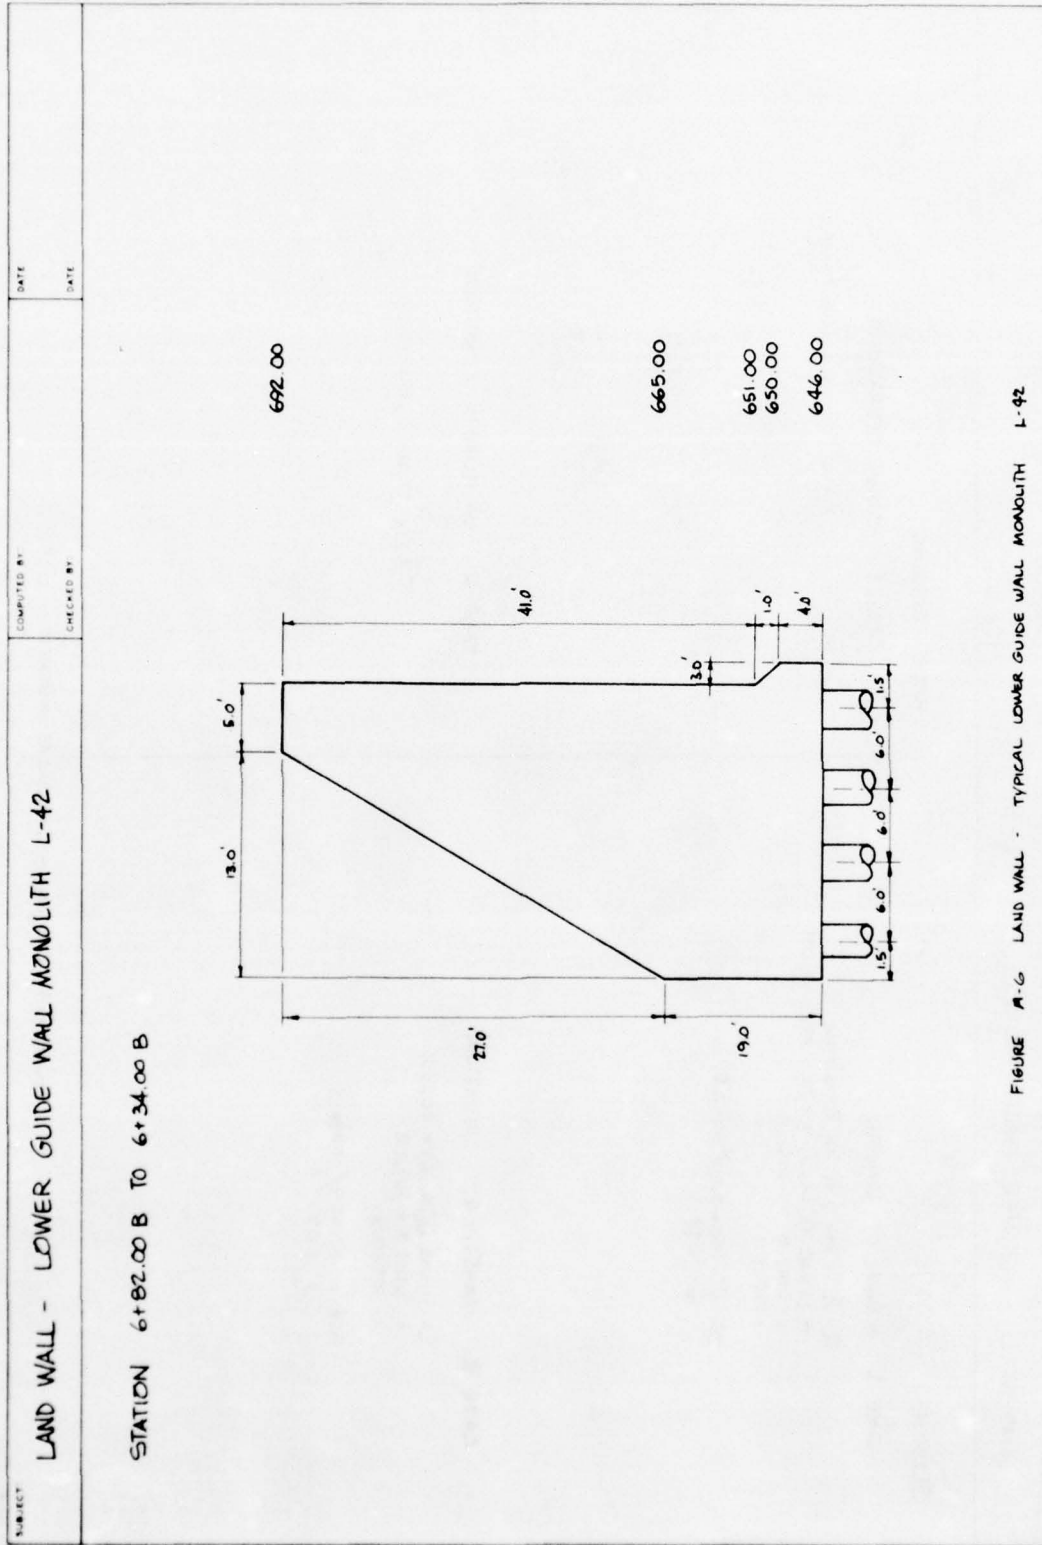
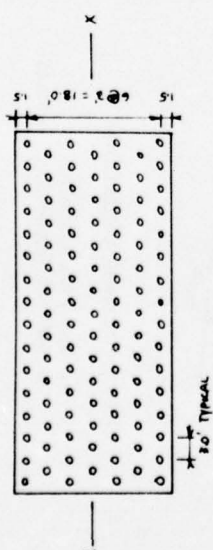
FIGURE A-6 LAND WALL - TYPICAL LOWER GUIDE WALL MONOLITH L-42

</div> <div style="margin-top: 20px;"> <p>ALLOWABLE LOAD PER PILE IN HORIZONTAL = 8 K</p> <p><math>F_H = 32.1^k \text{ per foot}</math></p> <p><math>(32.1)(48) = 1540.8^k = F_{H \text{ Total}}</math></p> <p>load per pile = <math>1540.8 / 109 = 14.14^k &gt; 8^k</math></p> </div>
			<div style="text-align: center;"> <p>BASE PILE PRESSURE</p> <p>I of the pile group about xx axis is 3115.5 ft<sup>4</sup></p> <math display="block">f = \frac{P}{A} + \frac{M_c}{I}</math> <math display="block">= \frac{(78.3)(48)}{(7834)(109)} + \frac{(78.3)(48)(22.49 - 10.5)(9)}{3115.5}</math> <math display="block">= 43.9 + 130.2</math> <math display="block">= 174.1 \text{ KSF}</math> <p>ALLOWABLE PER PILE = 100 K/pile</p> <p><math>174.1 \frac{K}{SF} \times 7834 \frac{SF}{pile} = 136.7 \frac{K}{pile} &gt; 100 \frac{K}{pile}</math></p> </div>

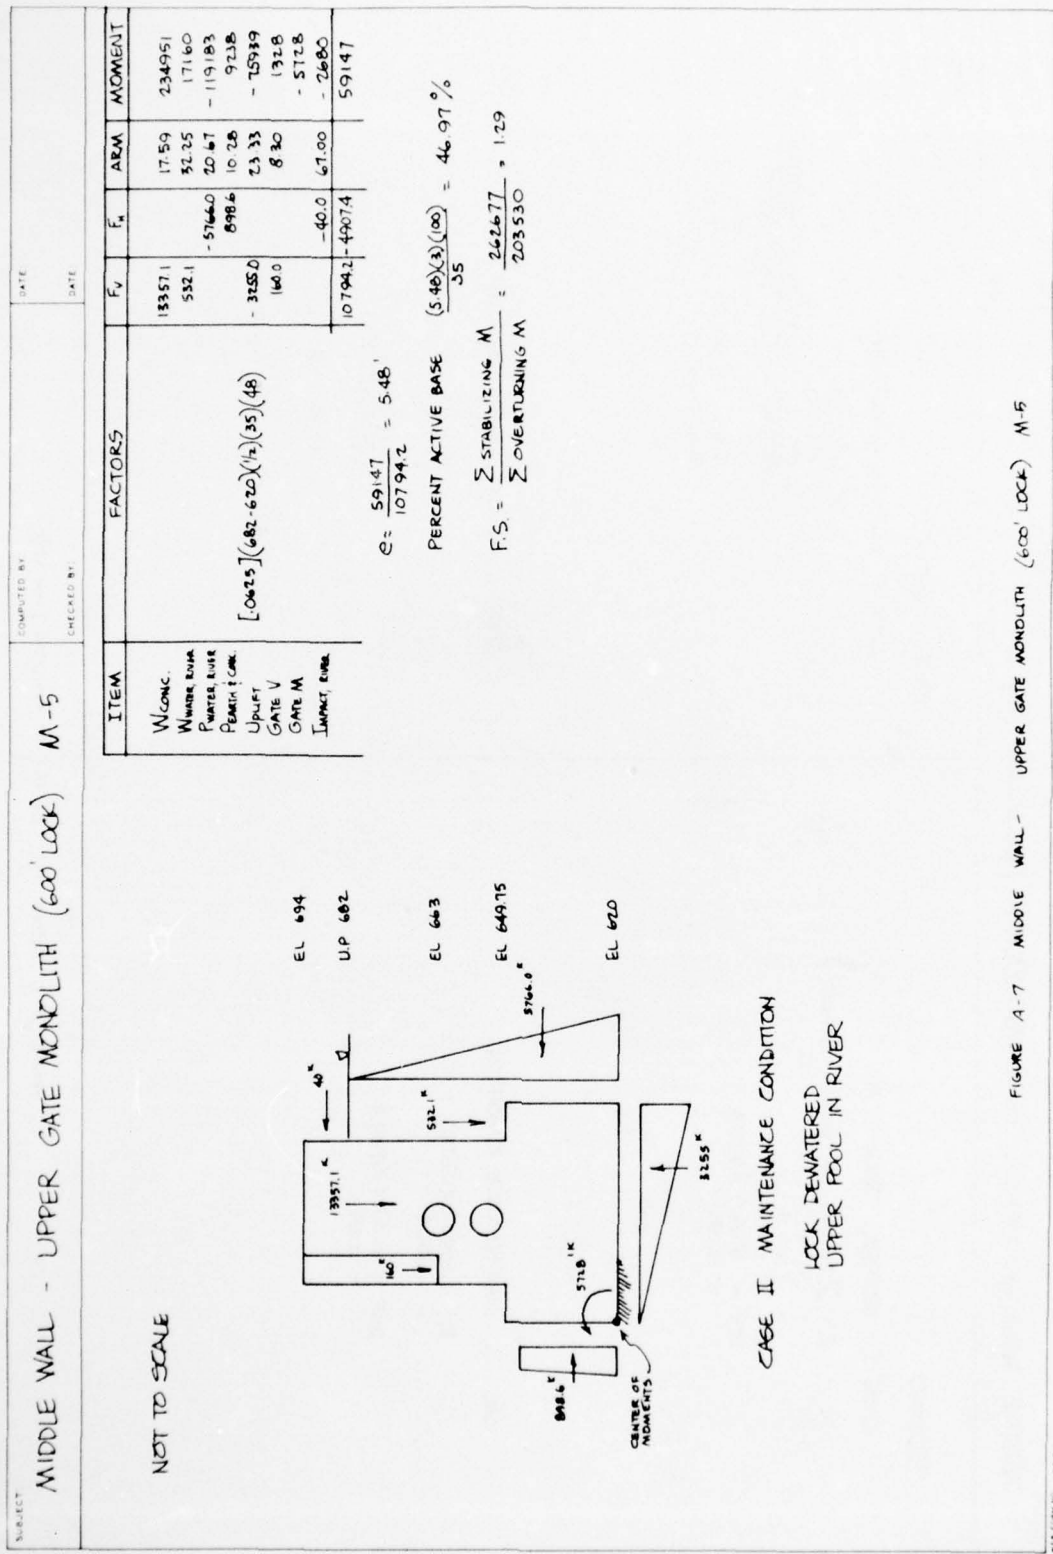
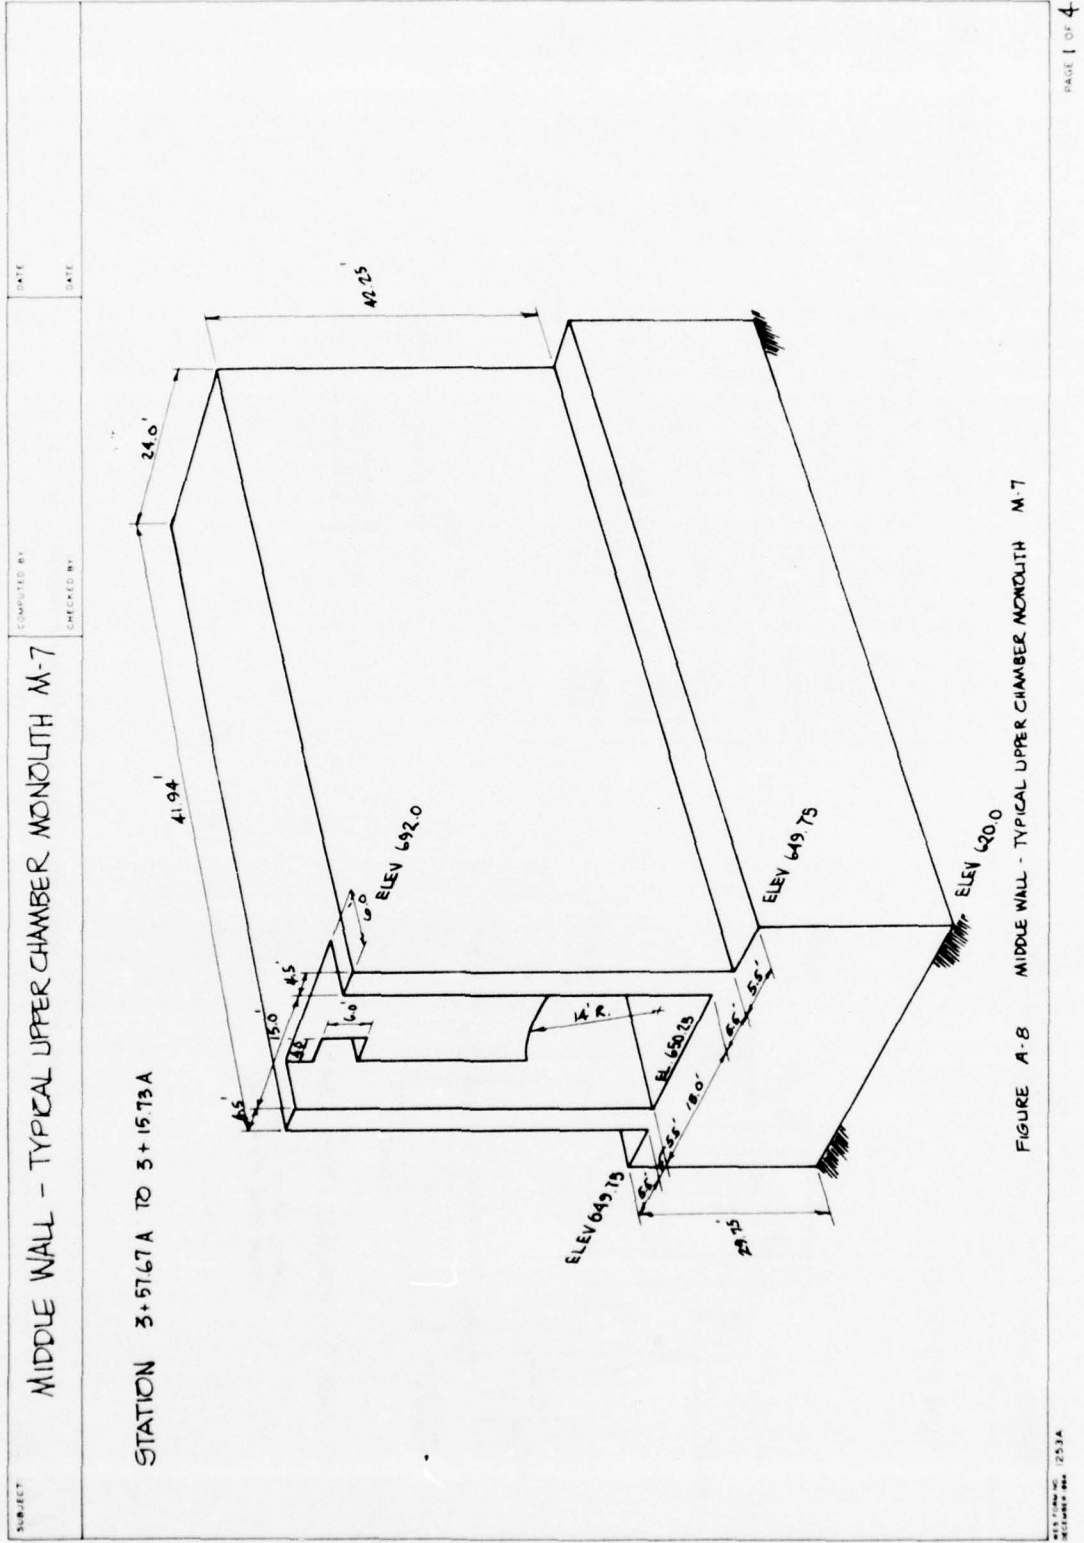
FIGURE A-7 MIDDLE WALL - UPPER GATE MONOLITH (600' LOCK) M-5

SUBJECT	COMPUTED BY	CHECKED BY	DATE
MIDDLE WALL - UPPER GATE MONOLITH (600' LOCK) M-5			
<p>SLIDING</p> <p>CASE I NORMAL OPERATIONS</p> $R = \sum F_v \tan \phi + \text{Key Resistance}$ $= (9132.1)(.5658) + 0$ $= 5166.9$ $SSF = 5166.9 / 572.3$ $= 9.03$	<p>BASE PRESSURE</p> <p>CASE I NORMAL OPERATIONS</p> $f = \frac{P}{A} + \frac{M \bar{c}}{I}$ $= \frac{9132.1}{(35)(48)} + \frac{(9132.1)(17.5 - 14.03)(17.5)(12)}{(48)(35)^3}$ $= 5.44 + 3.23$ $= 8.67 \text{ KSF}$	<p>CASE II MAINTENANCE CONDITION</p> $R = (10794.2)(.5658) + 0$ $= 6107.4$ $SSF = 6107.4 / 4907.4$ $= 1.24$	<p>CASE II MAINTENANCE CONDITION</p> $f = \left( \frac{2}{3} \frac{P}{e} \right) / l$ $= \frac{(2)(10794.2)}{(3)(548)} / 48$ $= 27.36 \text{ KSF}$

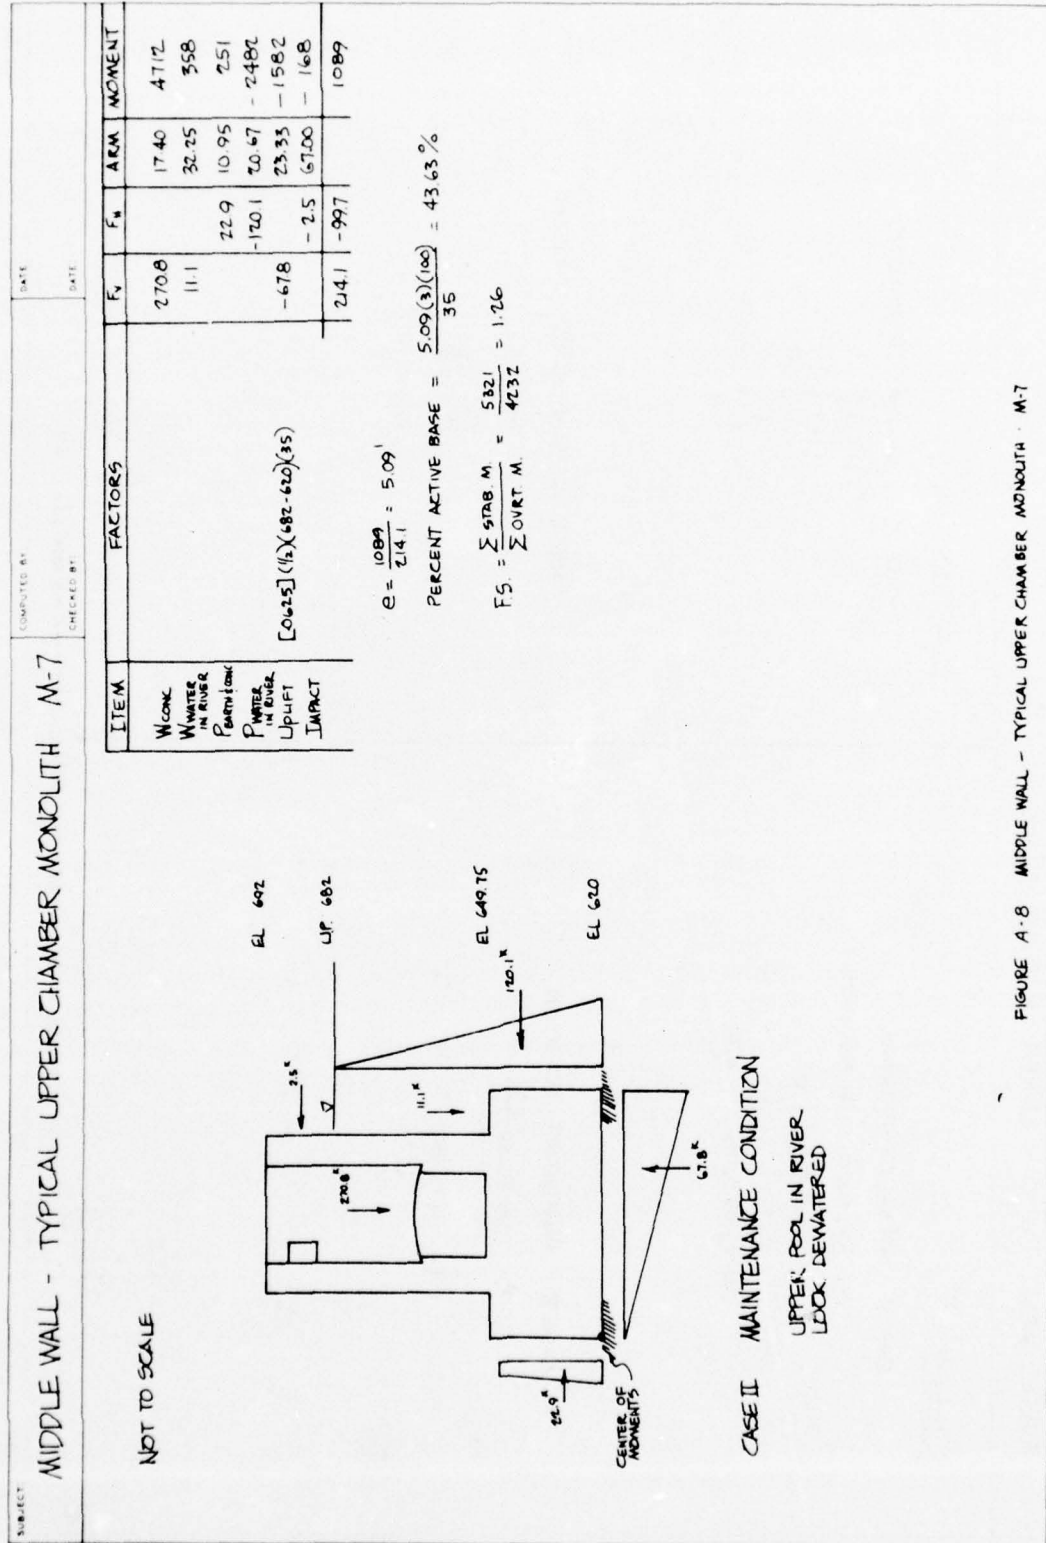
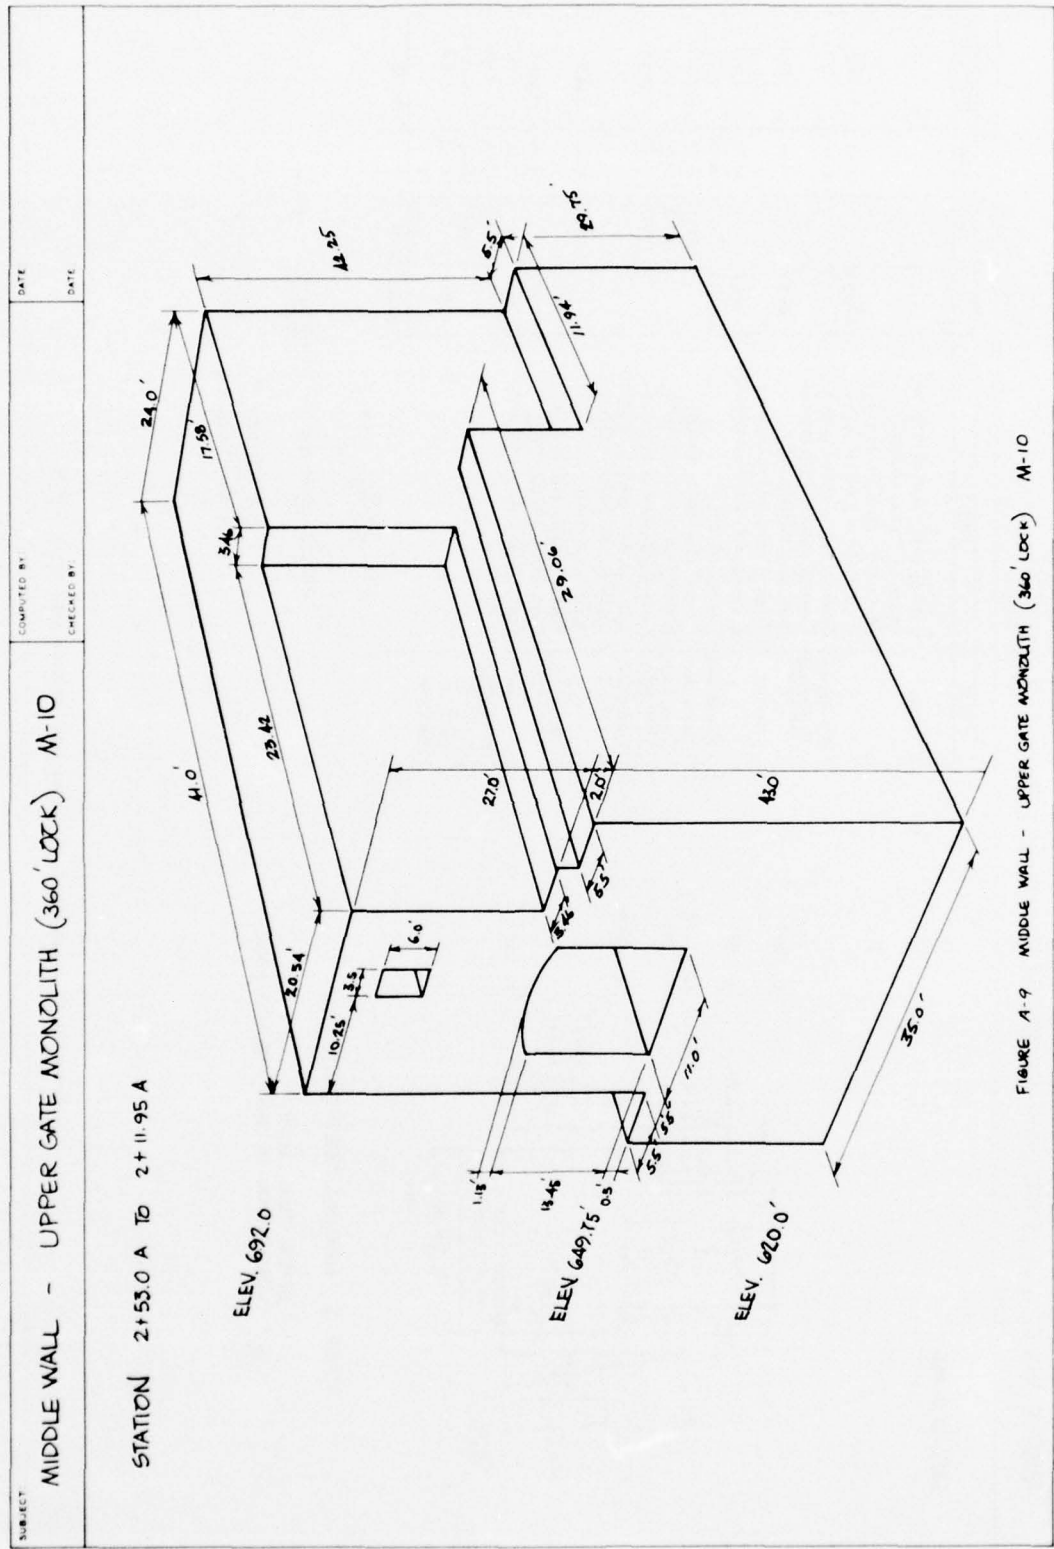
FIGURE A-8 MIDDLE WALL - TYPICAL UPPER CHAMBER MONOLITH M-7

SUBJECT		COMPUTED BY	DATE	CHECKED BY	DATE
MIDDLE WALL - TYPICAL UPPER CHAMBER MONOLITH M-7					
<p><b>SLIDING</b></p> <p><b>CASE I NORMAL OPERATIONS</b></p> $R = \sum F_v \tan \phi + \text{KEY RESISTANCE}$ $= (182.0)(56.58) + 0$ $= 103.0$ $SSF = 103.0 / 38.6 = 2.67$		<p><b>BASE PRESSURES</b></p> <p><b>CASE I NORMAL OPERATIONS</b></p> $f = \frac{2}{3} \frac{P}{Q}$ $= \frac{(2)(182.0)}{(3)(8.88)}$ $= 13.67 \text{ KSF}$			
<p><b>CASE II MAINTENANCE CONDITION</b></p> $R = \frac{(24.1)(56.58)}{112.1} + 0$ $SSF = 112.1 / 99.7 = 1.12$		<p><b>CASE II MAINTENANCE CONDITION</b></p> $f = \frac{2}{3} \frac{P}{Q}$ $= \frac{(2)(24.1)}{(3)(5.08)}$ $= 28.04 \text{ KSF}$

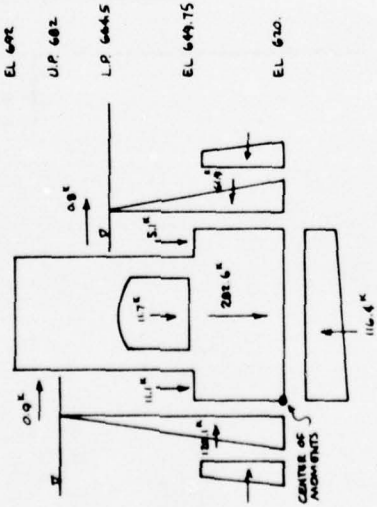
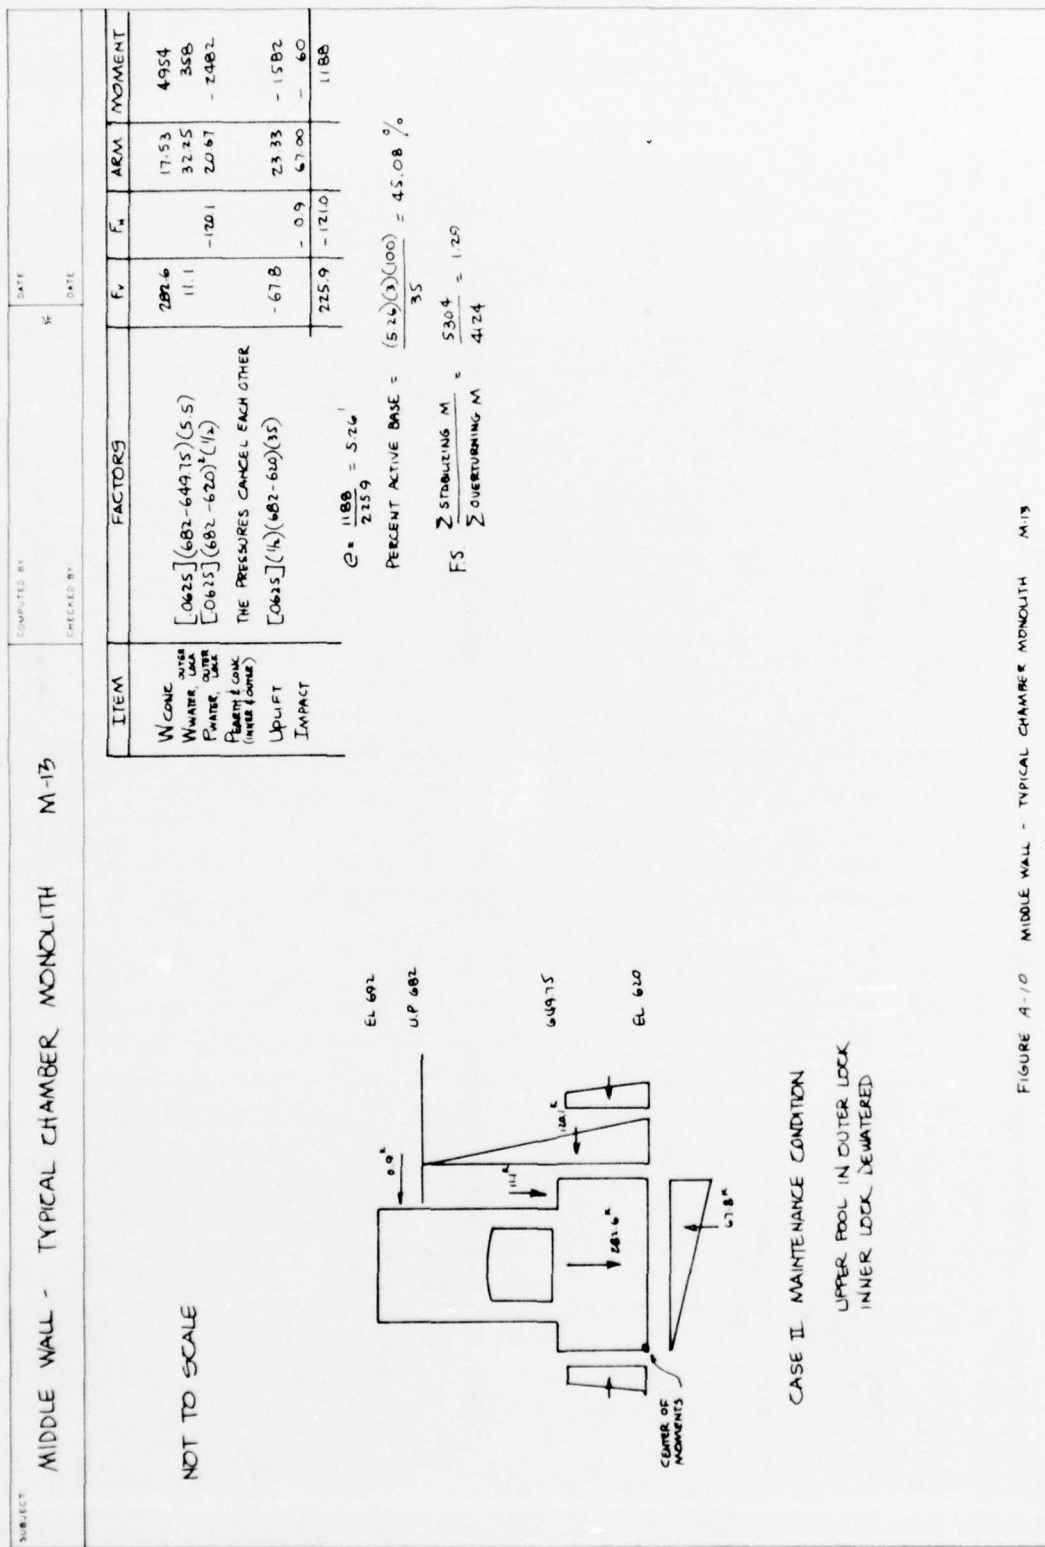
FIGURE A-10 MIDDLE WALL - TYPICAL CHAMBER MONOLITH M-13

$$FS = \frac{\sum \text{STABILIZING } M}{\sum \text{OVERTURNING } M} = \frac{6627}{4923} = 1.35$$

SUBJECT	MIDDLE WALL - TYPICAL CHAMBER MONOLITH M-13	COMPUTED BY	DATE
		CHECKED BY	DATE
<p>SUDING</p> <p>CASE I NORMAL OPERATIONS</p> $R = \Sigma F \tan \phi + \text{Key Resistance}$ $= (194.1)(.5658) + 0$ $= 109.8$ $SSF = 109.8 / 59.9$ $= 1.83$		<p>BASE PRESSURE</p> <p>CASE I NORMAL OPERATIONS</p> $f = \frac{2}{3} \frac{P}{C}$ $= \frac{(2)(194.1)}{(3)(8.78)}$ $= 14.73 \text{ KSF}$	
<p>CASE II MAINTENANCE CONDITION</p> $R = (225.9)(.5658) + 0$ $= 127.8$ $SSF = 127.8 / 121.0$ $= 1.06$		<p>CASE II MAINTENANCE CONDITION</p> $f = \frac{2}{3} \frac{P}{C}$ $= \frac{(2)(225.9)}{(3)(5.26)}$ $= 28.63 \text{ KSF}$

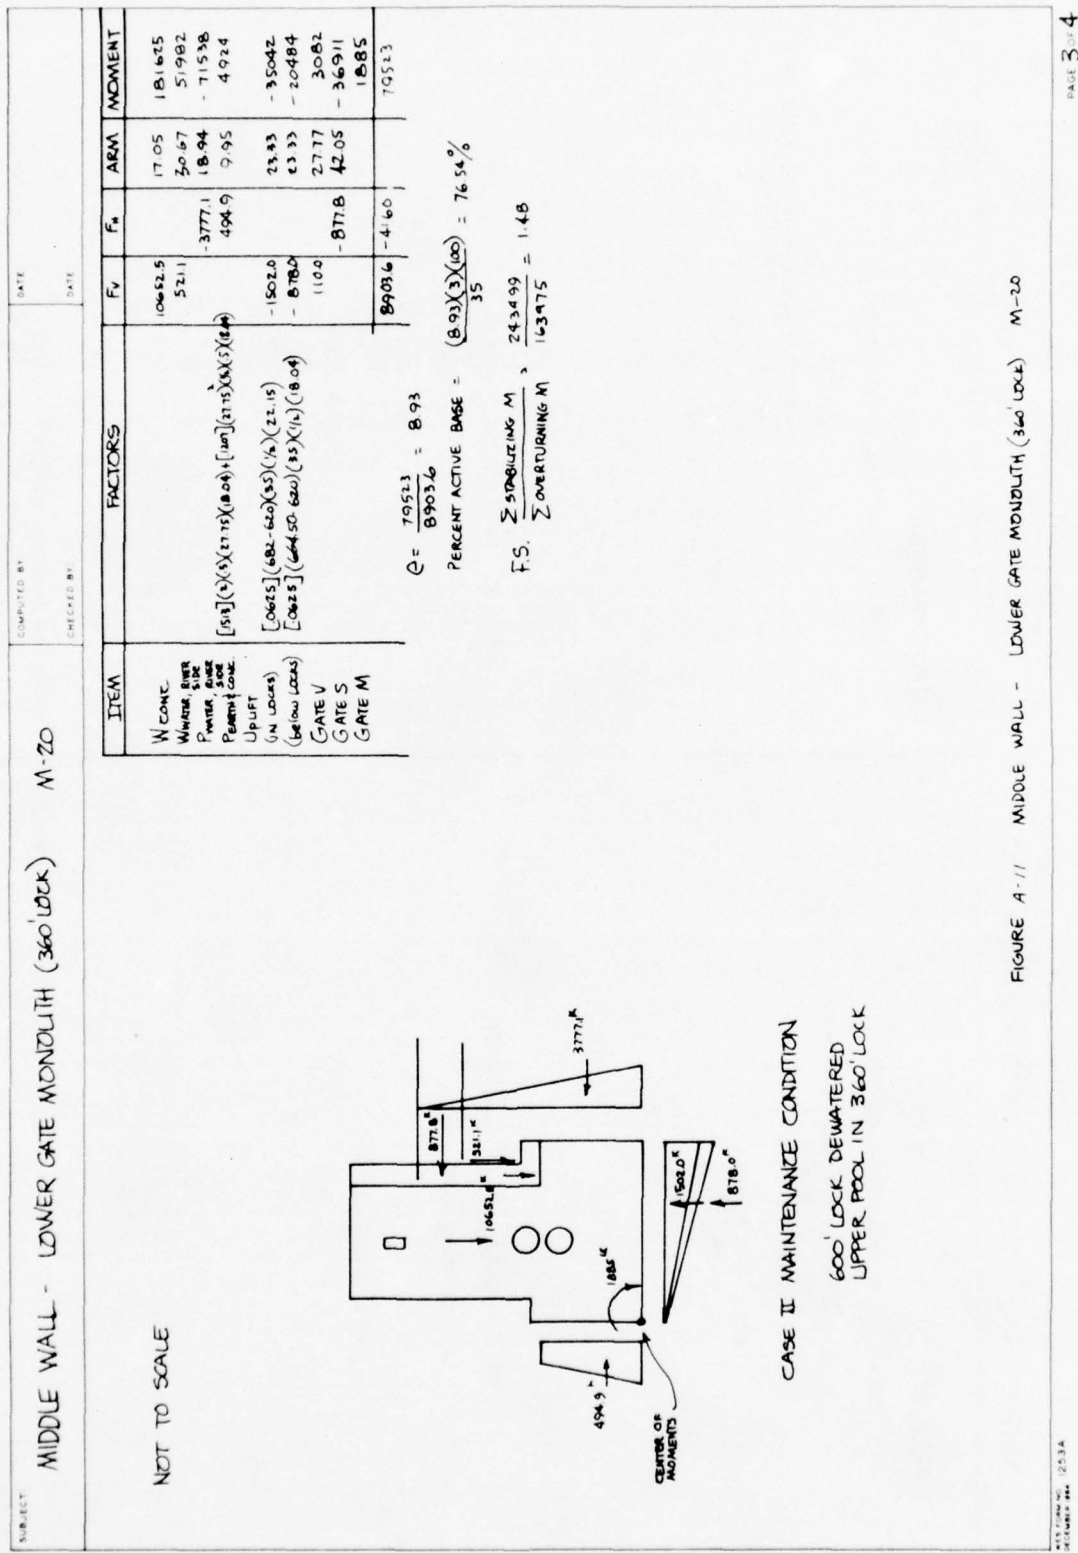
FIGURE A-11 MIDDLE WALL - LOWER GATE MONOLITH (360' LOCK) M-20

SUBJECT	COMPUTED BY	DATE
MIDDLE WALL	LOWER GATE MONOLITH (360' LOCK)	M-20
SLIDING	<p>CASE I NORMAL OPERATIONS</p> $R = \sum FV \tan \phi + \text{Key Resistance}$ $= (7629.5)(5458) + 0$ $= 4316.8$ $SSF = 4316.8 / 1830.2$ $= 2.36$	<p>CASE I NORMAL OPERATIONS</p> $f = \frac{P}{A} + \frac{M \cdot c}{I}$ $= \frac{7629.5}{(35)(40.19)} + \frac{(7629.5)(17.5 - 13.18)(17.5)(12)}{(40.19)(35)^3}$ $= 5.42 + 4.02$ $= 9.44 \text{ KSF}$
<p>CASE II MAINTENANCE CONDITION</p> $R = (8903.6)(5458) + 0$ $= 5037.7$ $SSF = 5037.7 / 4160.0$ $= 1.21$	<p>CASE II MAINTENANCE CONDITION</p> $f = \left[ \frac{2}{3} \frac{P}{Q} \right] \div L$ $= \left[ \frac{(2)(8903.6)}{(3)(8)} \right] \div 40.19$ $= 16.53 \text{ KSF}$
